**Safety Standards and Inspection Techniques  
For Natural Gas Composite Cylinders**

Craig Webster  
Powertech Labs Inc.

September 1999

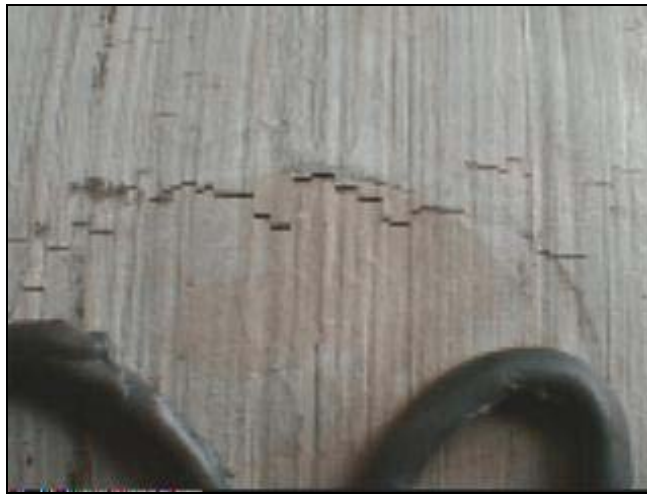
Figure 1: Damage to the Composite Wrapping

During this time, significant damage to the composite was produced, as shown on Figure 1.

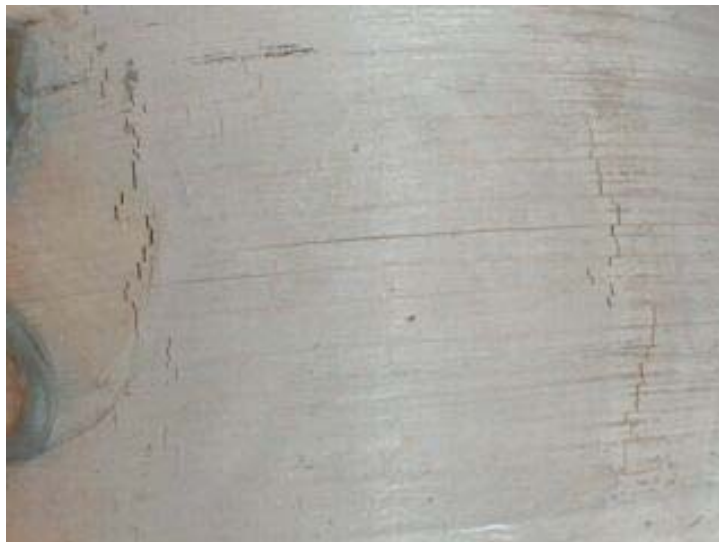
Figure 2: Damage to the Composite Wrapping

The test produced significant damages to the composite wrapping of the cylinder. Several major cracks were apparent, either at the location of the acid patch and on several other locations on the sidewall, as shown in Picture 2.

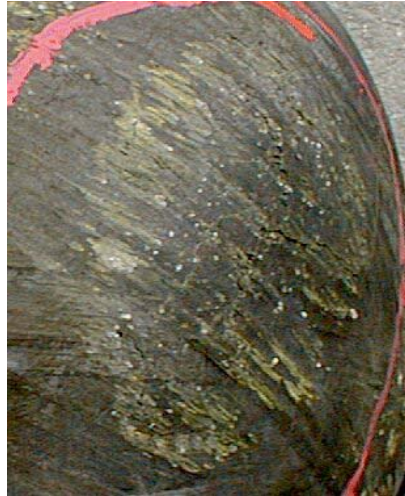
Figure 4: Damage Due to Cylinder Drop.

For each cylinder, the drop provoked important damage to the wrapping, as shown by Figure 4, with apparent cracks and delamination.

Visual inspection revealed that for each cylinder, the damaged area is more important for the second hit, after rebound. This can be seen by the size of the damaged surface as well as the length of the cracks in the superficial layers of the wrapping.

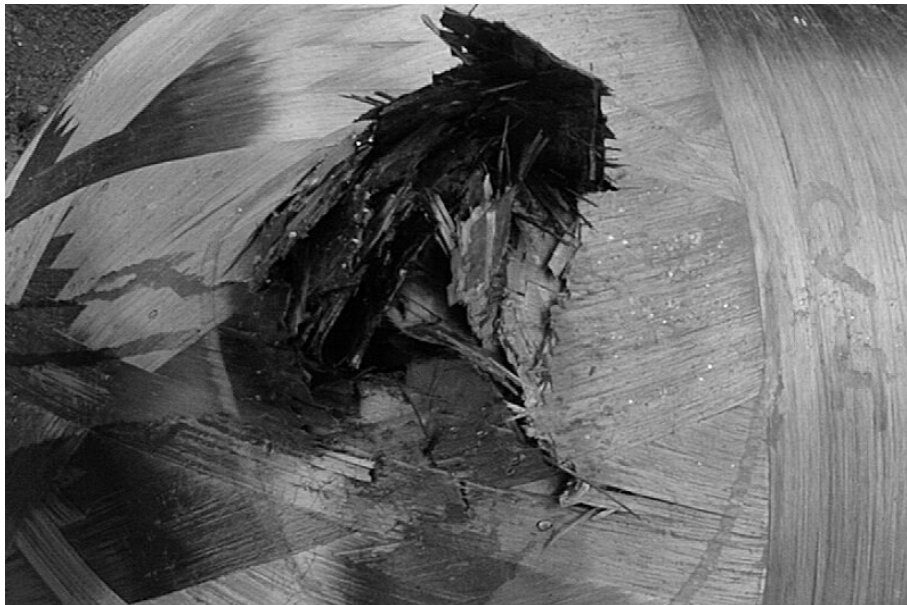
Figure 5: Failure of the Cylinder

The cylinder also failed during the first pressurization. The burst pressure was 129 bar (1870 psi). The failure occurred on the spot of the second hit, as for the two previous cylinders.
